**CALSPAN ON-SITE AIR BAG/ARM FRACTURE
CRASH INVESTIGATION**

CALSPAN CASE NO. 94-42

VEHICLE #1 - 1991 DODGE SPIRIT

VEHICLE #2 - 1985 FORD TEMPO GL

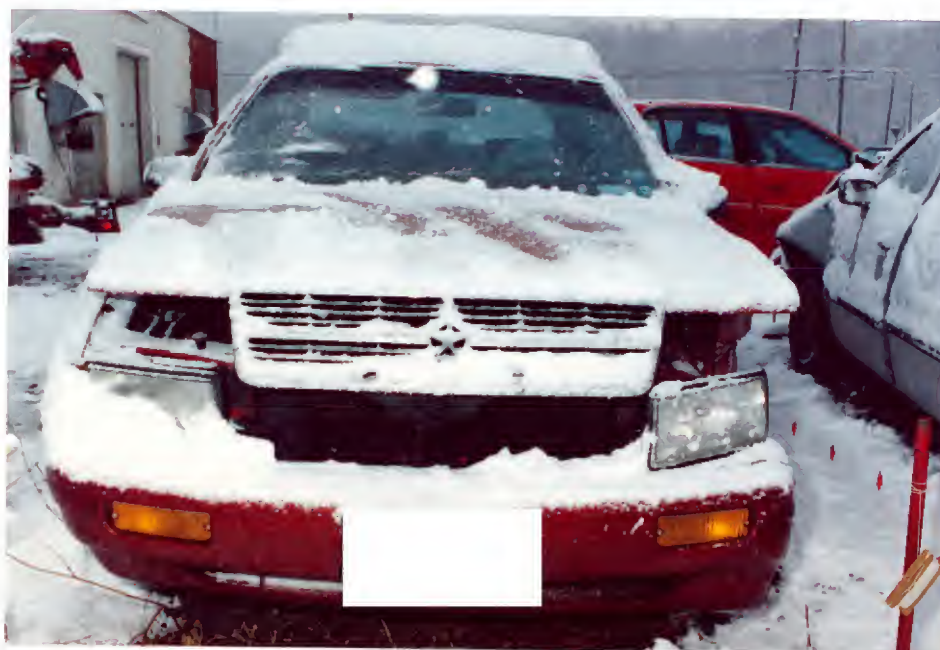
Components damaged in the crash included the front bumper, the left front headlight assembly, the front fender, the left front wheel (refer to photographs #14 - #21) and the left rear fender (refer to photograph #22 - #24). The left wheelbase was reduced by 5.8 cm (2.3"). The front bumper energy absorbing devices (EAD) did not exhibit any stroking from impact compression.

14. Frontal view of the 1991 Dodge Spirit (Vehicle #1).

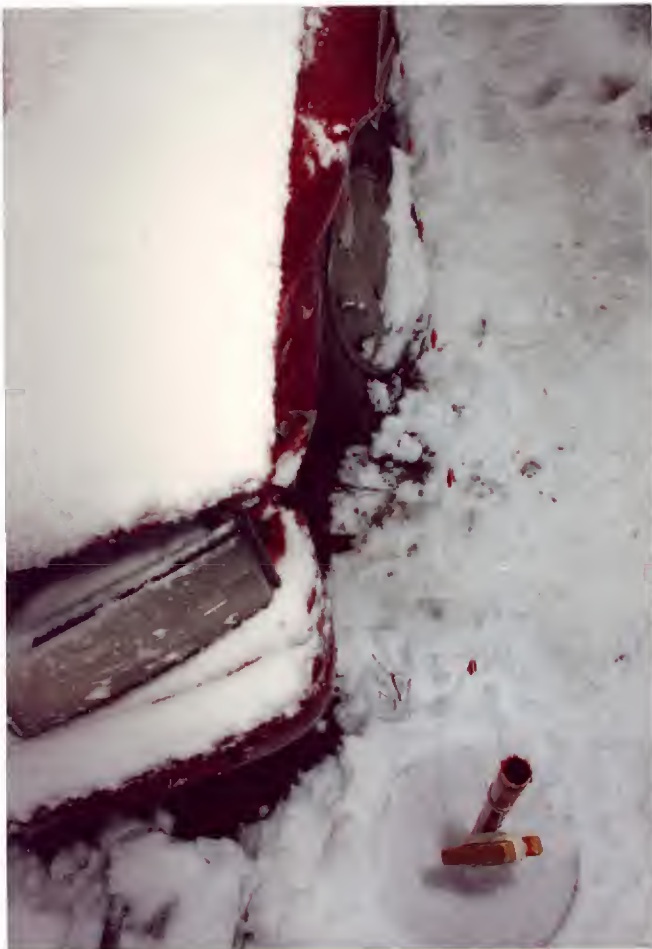
16. Overhead view of the lateral crush pattern along the left front fender.

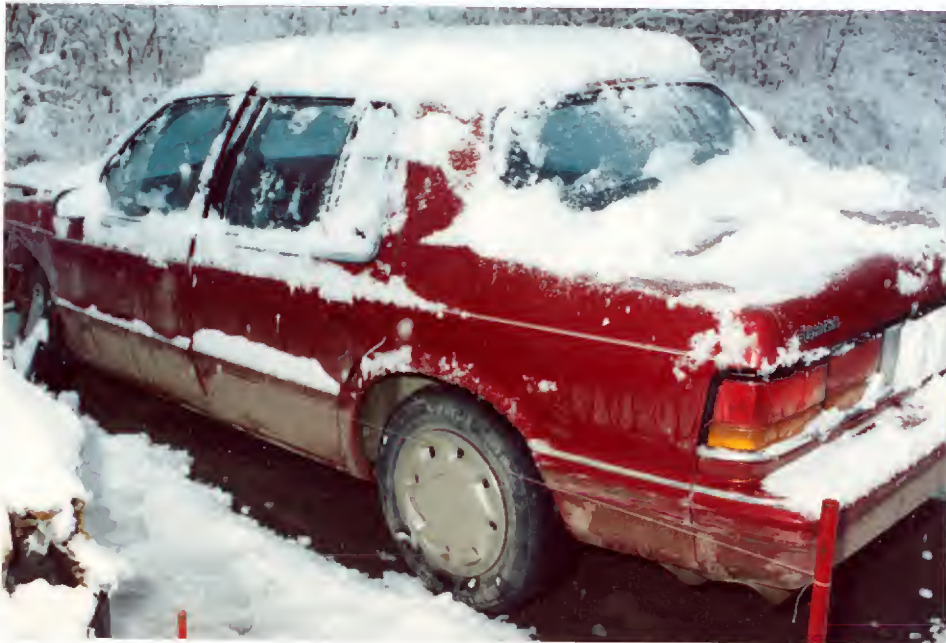
The direct contact damage for the second impact began at the left rear bumper corner and extended forward 66.0 cm (26.0"). Crush values for Vehicle #1 are listed below:

22. View of Vehicle #1's left side plane showing a light sideslap contact pattern from contact with Vehicle #2 which extended 66 cm (26") forward from the left rear bumper corner.

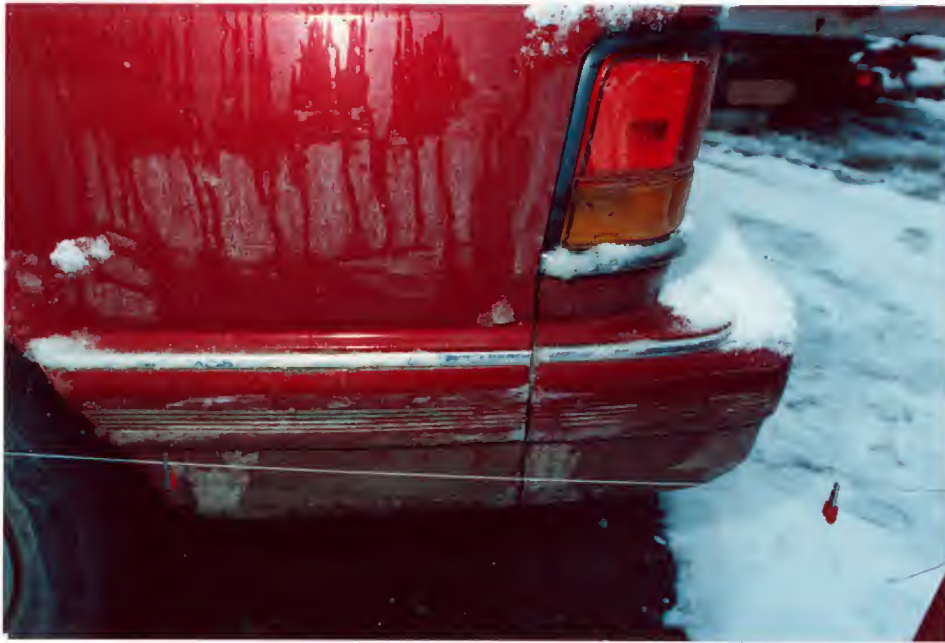
23. Close-up view of the sideslap contact pattern.

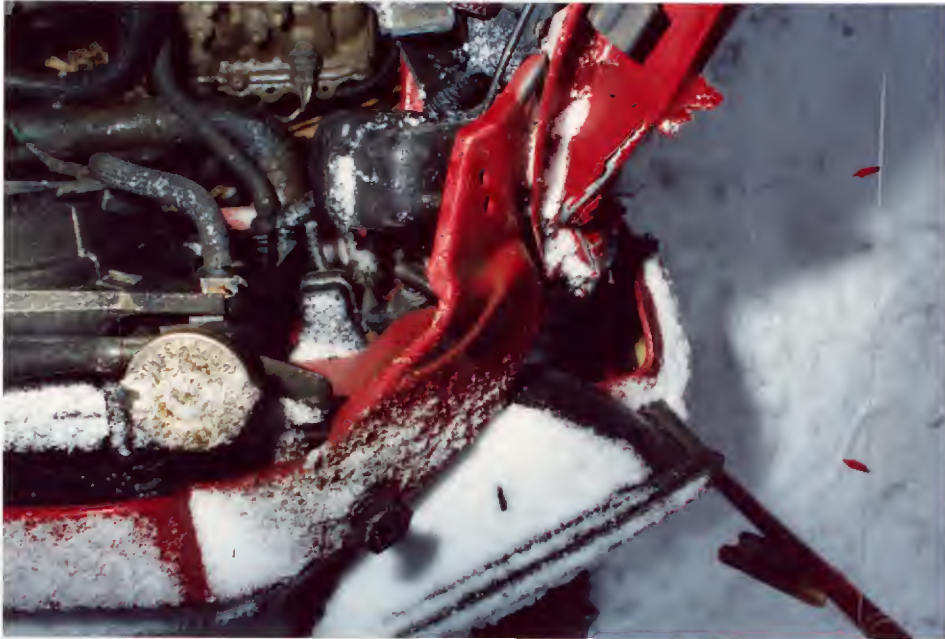
29. Overhead view of the left front fender corner showing the relationship between the deformation and the left front air bag impact sensor.

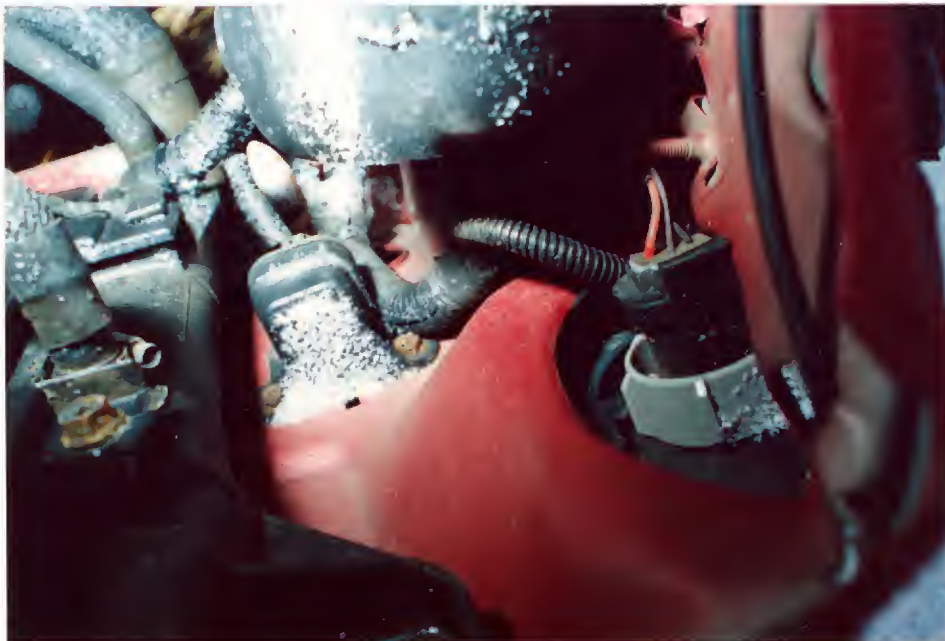
The vehicle was equipped with two forward impact sensors which were attached to the inner surface of the headlight mounting panel. These were located 40.6 cm (16.0") left and right of the vehicle centerline. Neither sensor was damaged during the crash.

30. Close-up overhead view of the left front impact sensor.

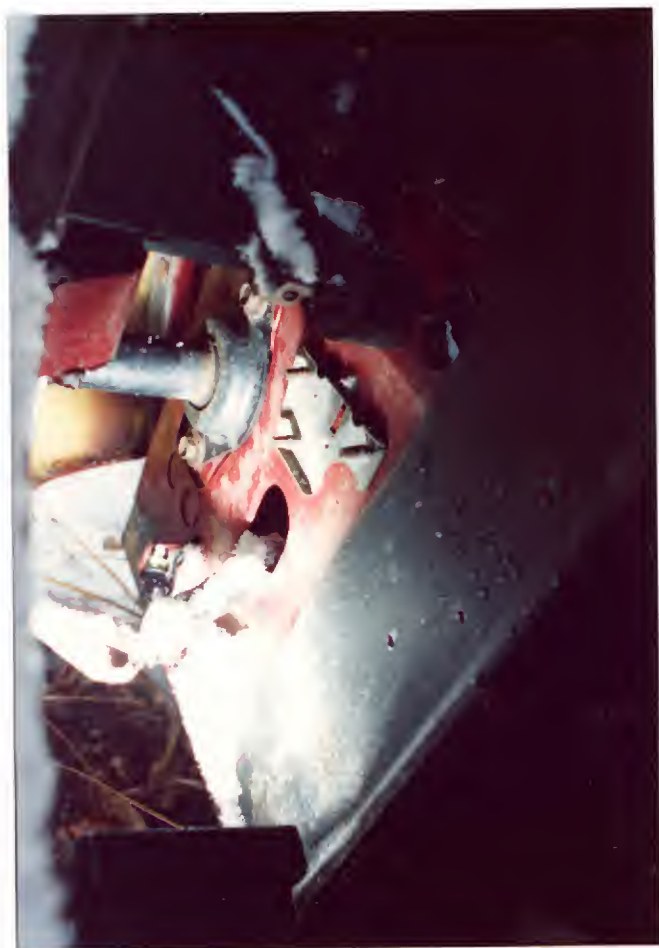
31. View of the left front bumper energy absorbing device (EAD) indicating no compression.

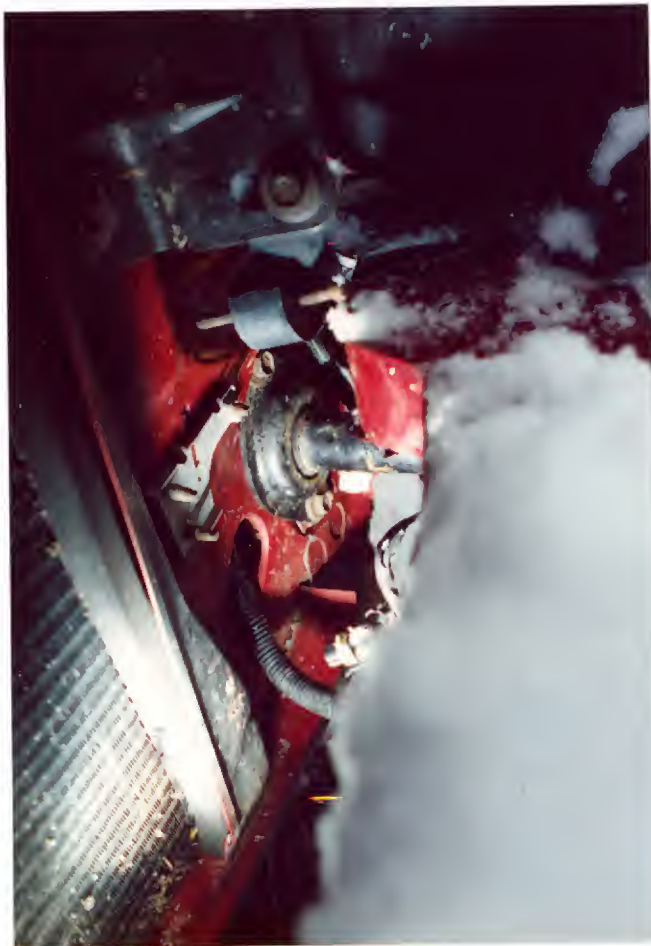
32. View of the right front bumper EAD indicating no compression.

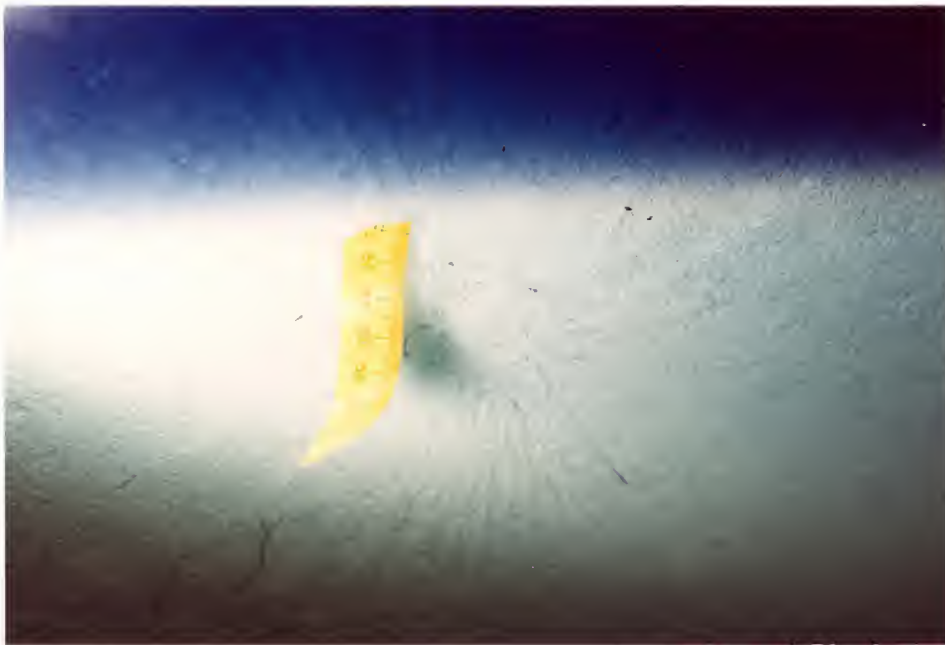
34. View of the driver's side of Vehicle #1 highlighting driver contact on the windshield and the deployed air bag.

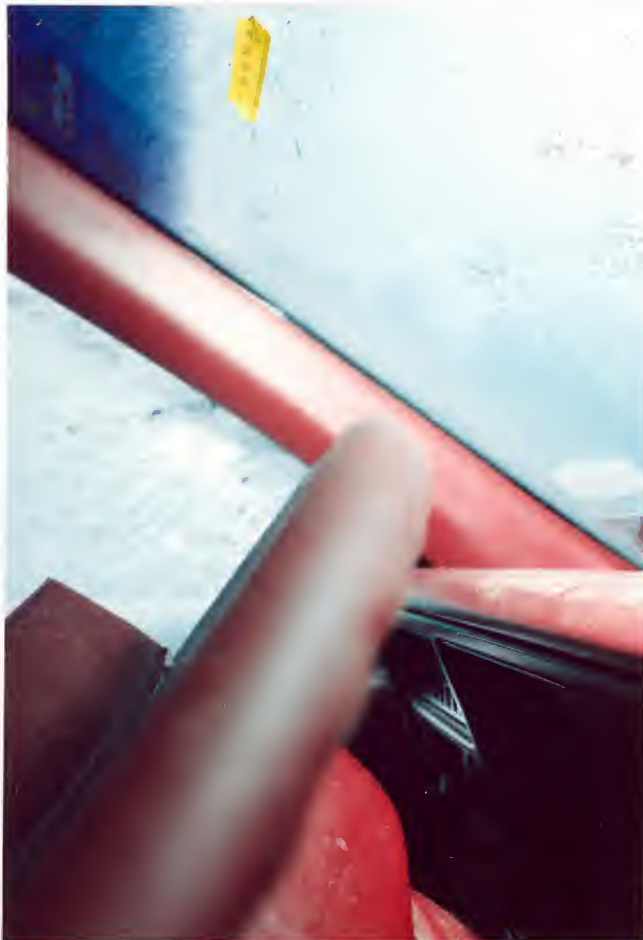
35. Close-up view of the spider web contact pattern on the windshield.

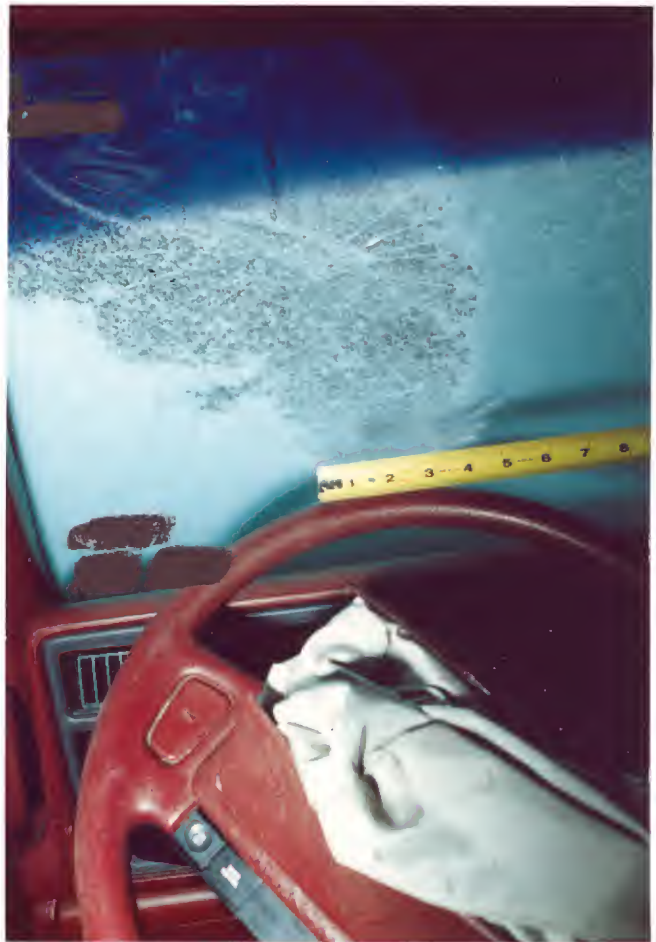
36. View of the contact pattern on the windshield in relationship to the steering wheel rim taken from the right side of the vehicle.

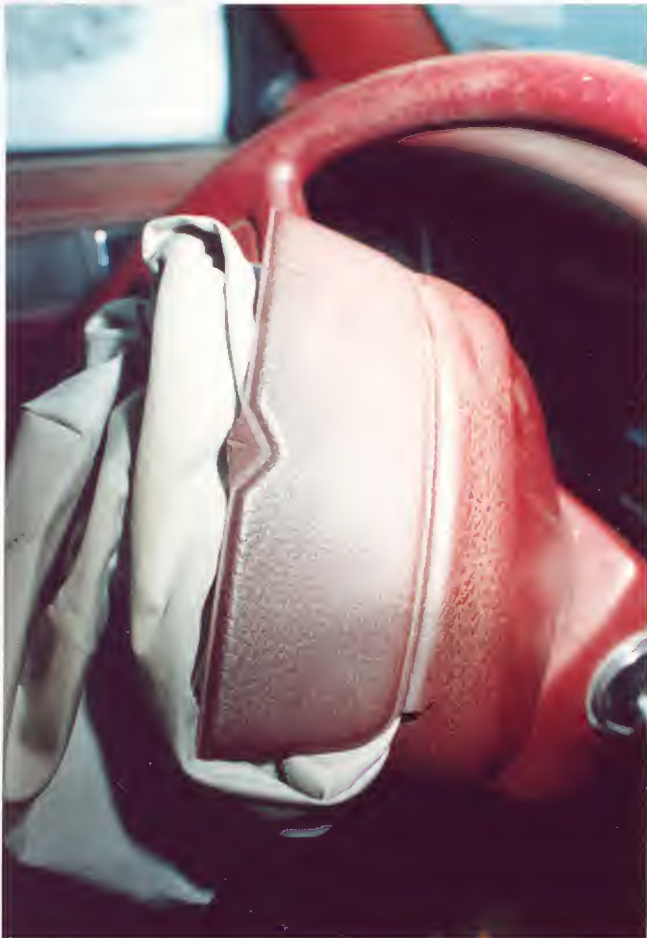
37. View of the spider web contact pattern with respect to the top dead center of the steering wheel rim.

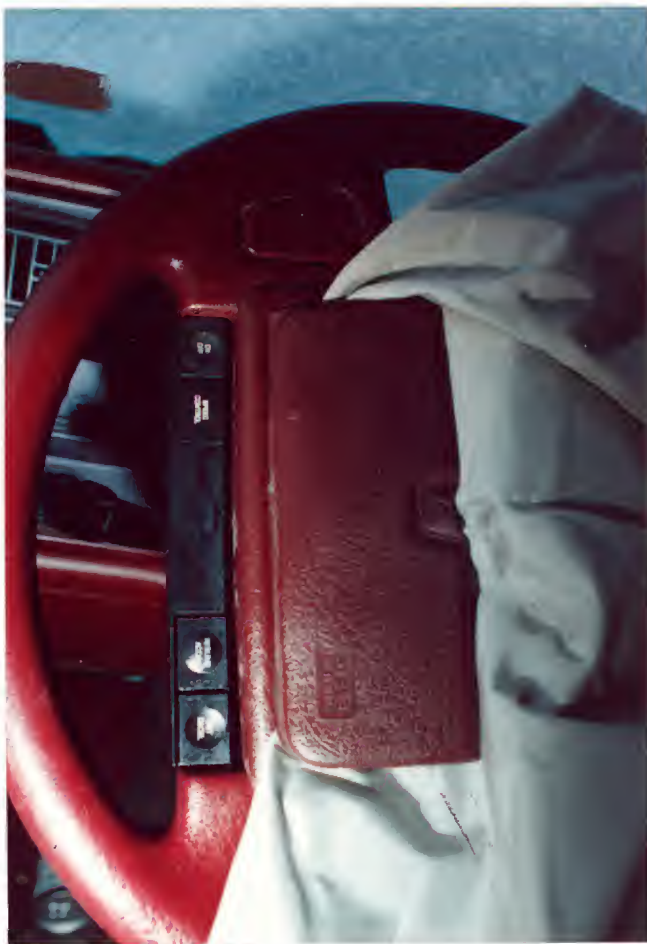
Interior damage to the 1991 Dodge Spirit was associated with the air bag deployment and contact by the driver. The air bag module cover opened along the designed tear seam lines in the typical "H" configuration deployment pattern. A light red lipstick transfer was noted in Quadrant II (i.e., upper right quadrant) as shown in Figure 1. on page 10.

38. View of the upper flap of the air bag module cover.

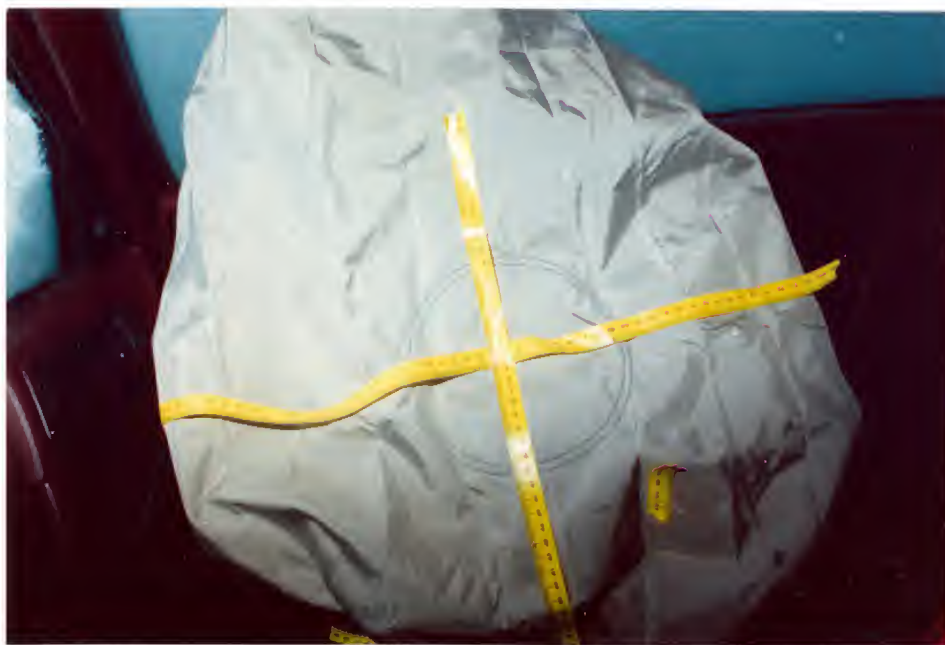
39. View of the lower flap of the air bag module cover.

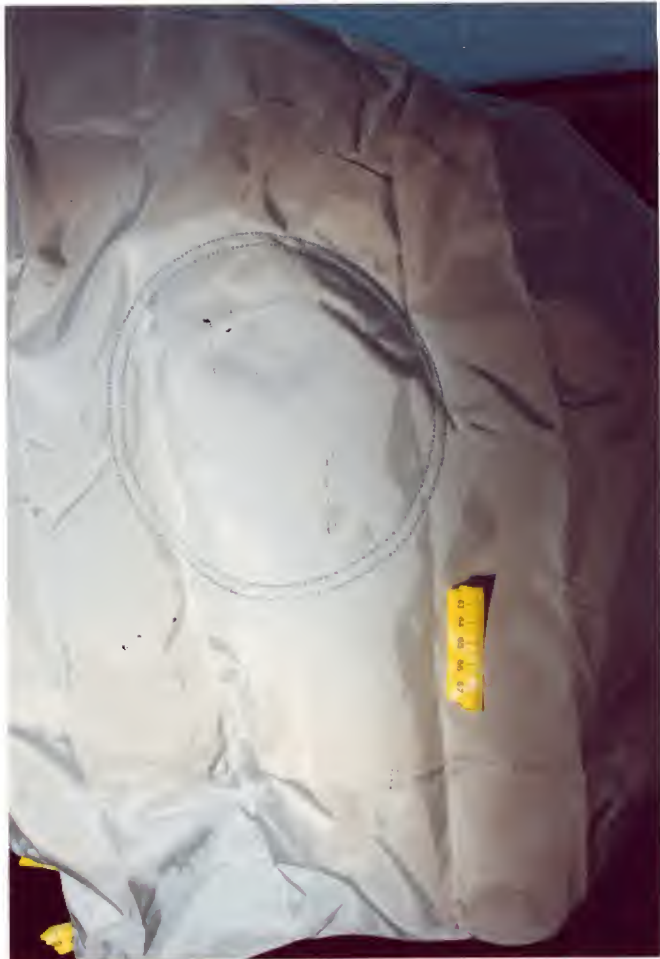
40. View of the driver air bag rotated 80° clockwise as observed upon inspection.

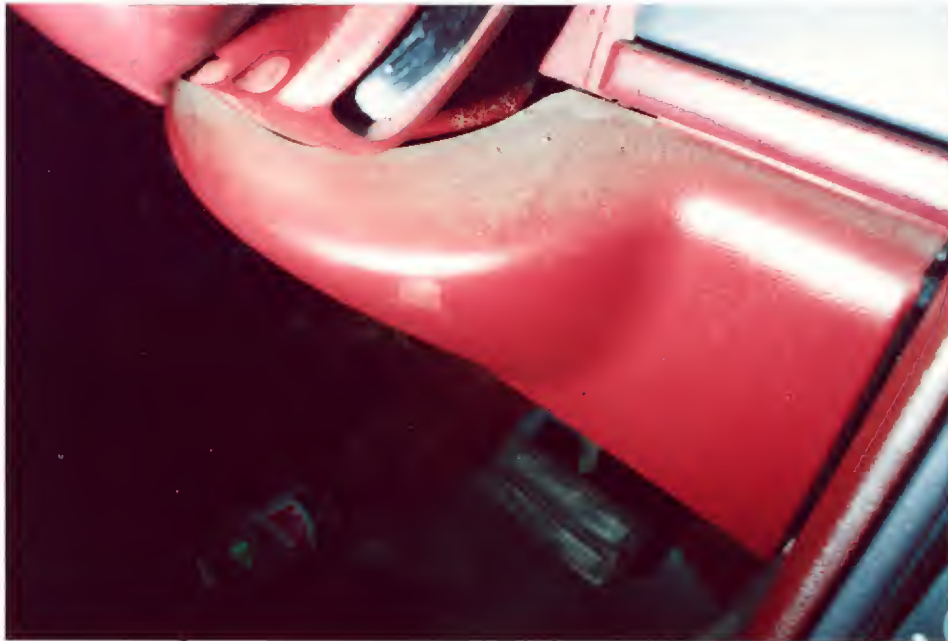
47. View of the knee bolster showing a light tan transfer.

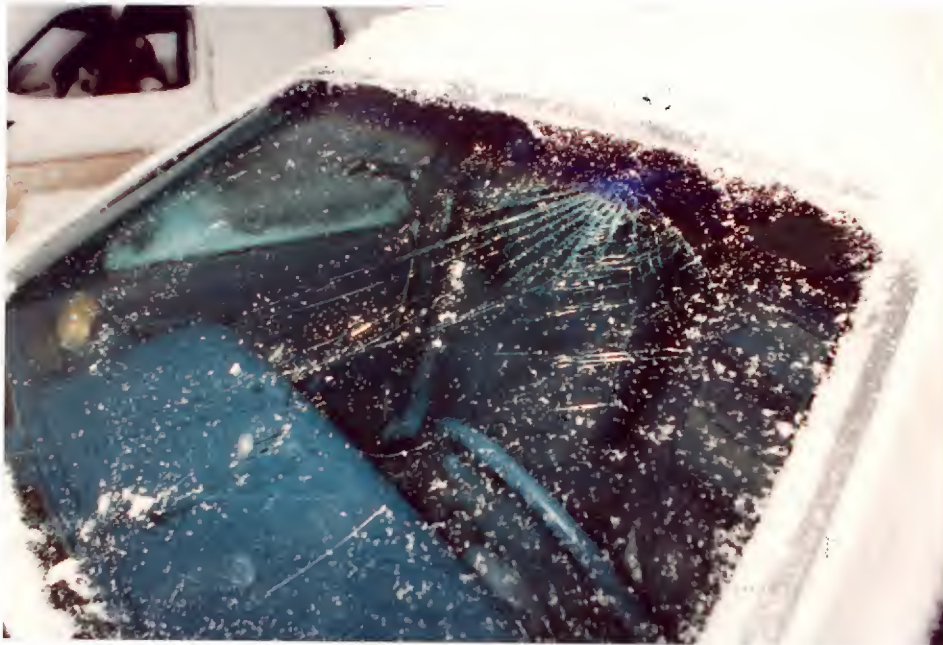
58. View of windshield showing spider web contact patterns resulting from contact by the driver and right front passenger.

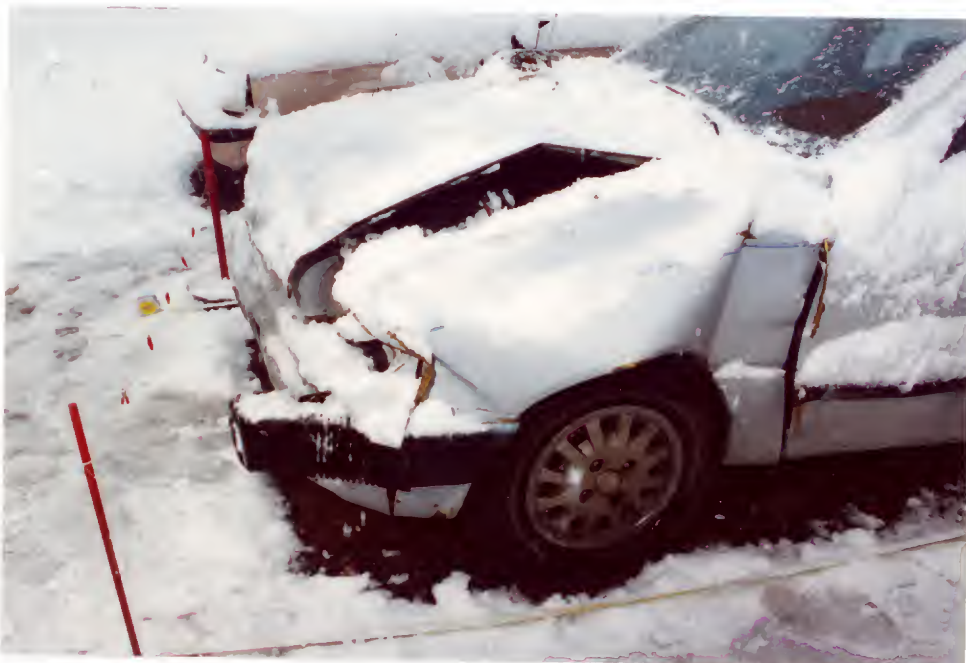
61. Longitudinal view of the vehicle's left side plane showing body profile displacement.

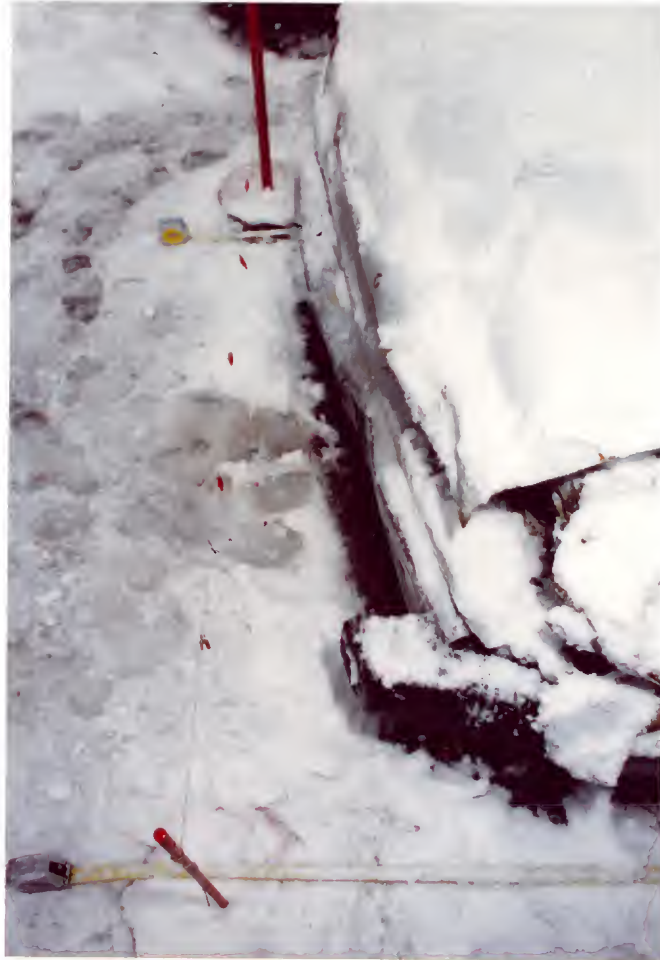
62. Lateral view of the frontal plane showing the rearward displacement of the front bumper.

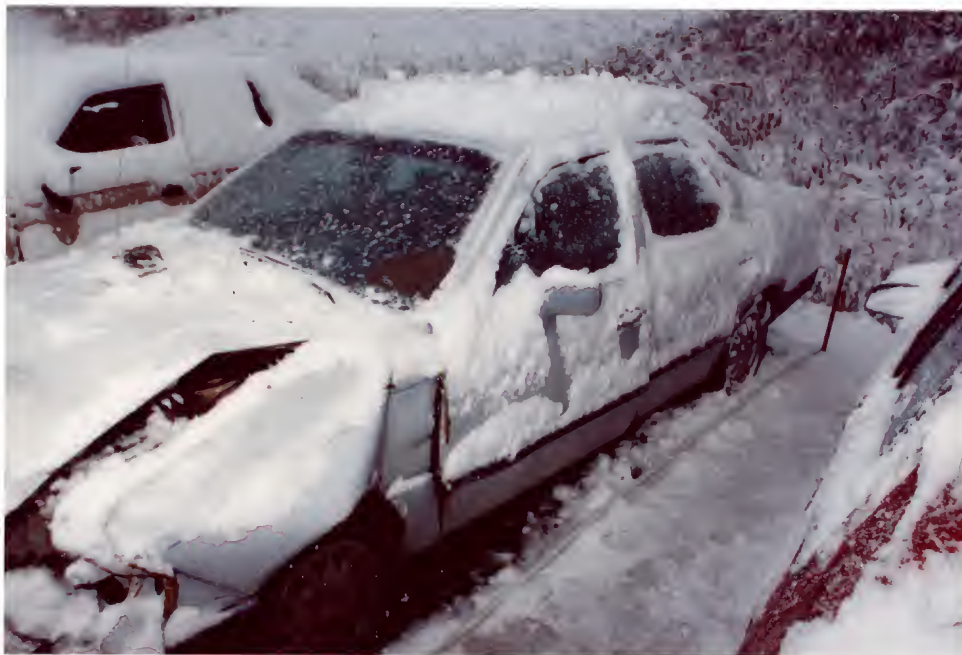
63. Overhead view of the frontal plane illustrating the crush profile.

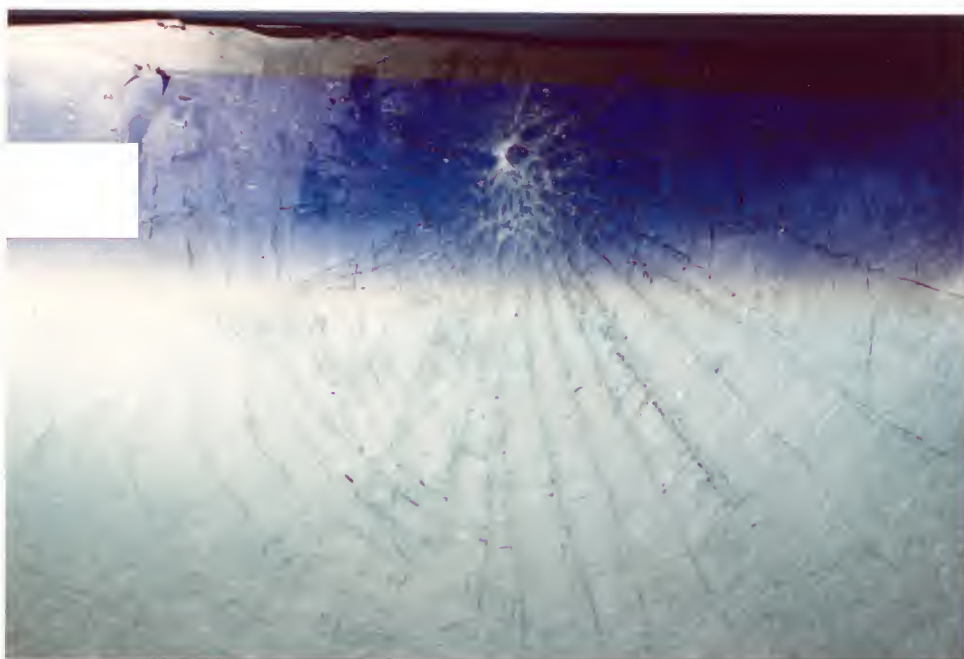
75. Vertical view of the left side of the instrument panel highlighting the spider web pattern in the windshield from driver contact.
